# JINCHENG HARDWARE INDUSTRY CO.,LTD

## TEST REPORT

EN 1634-1:2014+A1:2018 TESTING ON HINGE, MODEL OF 4X3X3

191025003SHF-001

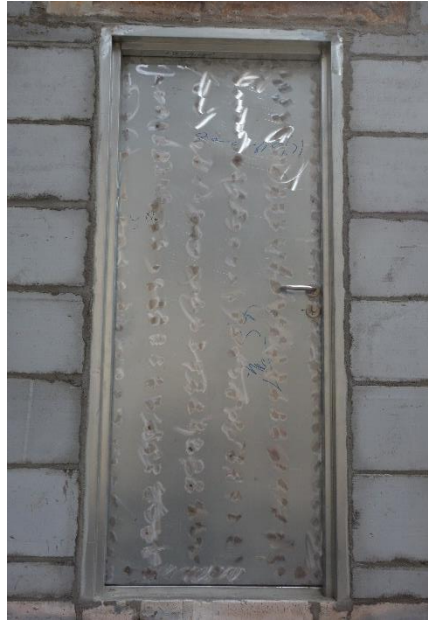
Fig. 1 Exposed Side Prior to the Fire Test

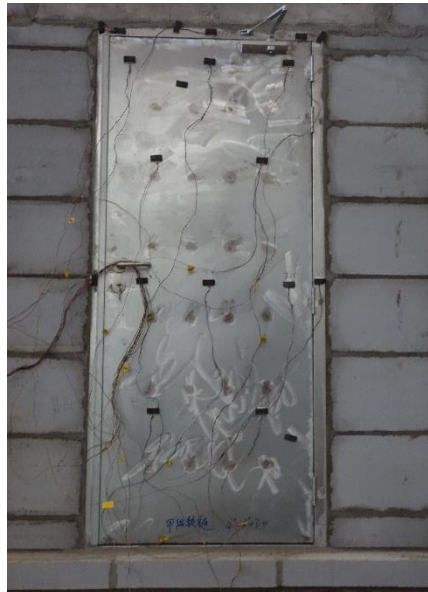
Fig. 2 Unexposed Side Prior to the Fire Test

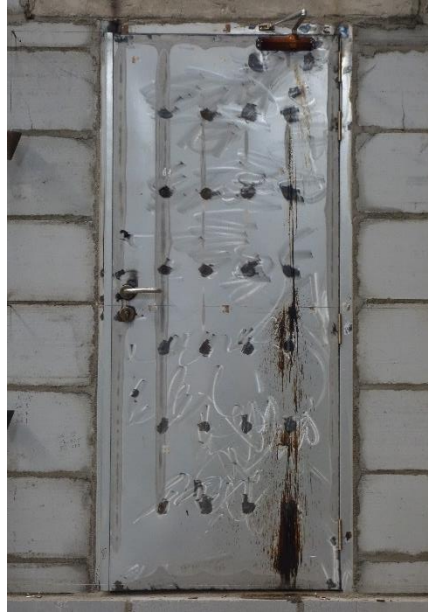
Fig. 3 Unexposed Side after 90 Minutes

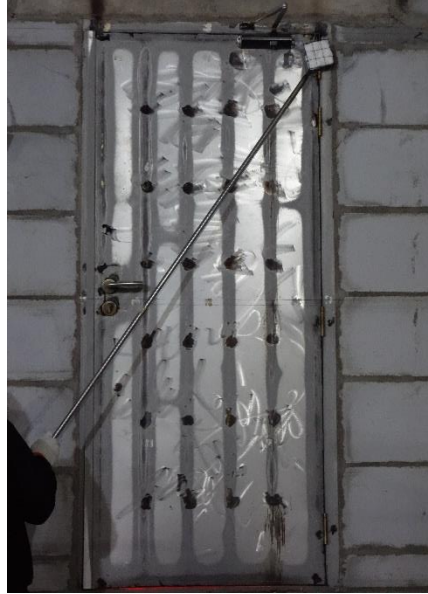
Fig. 5 Cotton pad test after 257 Minutes

| Time | | All observations are from the unexposed face unless noted otherwise. |
|---|---|---|
| 257 | 13 | A cotton pad was applied on the top hinge position of doorset. The pad was not ignited. |

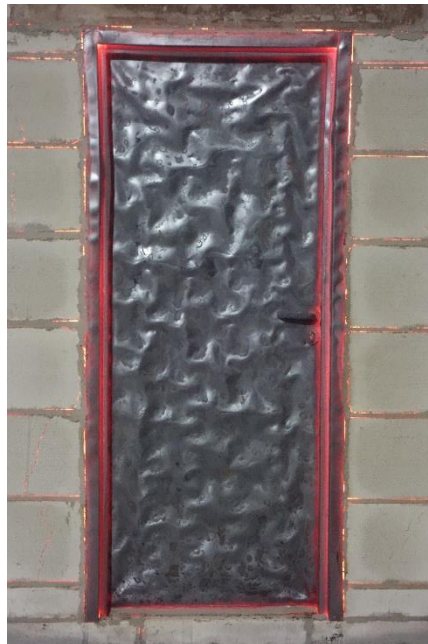
Fig. 6 Exposed Side after 260 Minutes
